# **Wind farm owner's view on rotor blades – from O&M to design requirements**

**BREMEN 25-27, February 2013**

**Antonio Herrera Sierra  
Eduardo García Pérez**

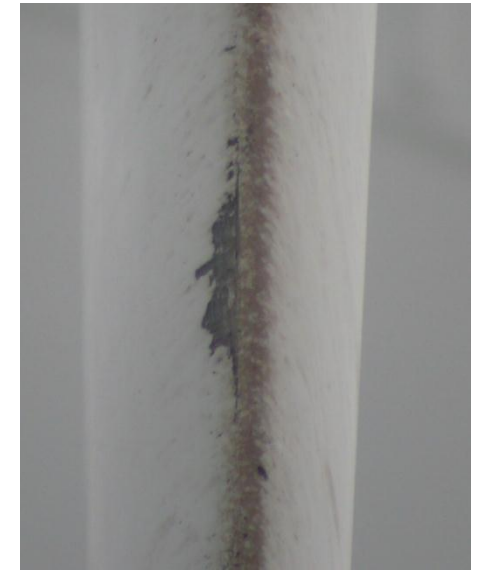
Example of a wind farm with 67 WT inspected after 14 years of operation:

Nº of blades (total 201)	% affected blades
Leading Edge Erosion	174	87%
Severe leading edge erosion	100	50%
Dirtiness, grease	197	98%
Gel coat debonding	54	27%
Transversal crack in pressure side	45	22%
Broken trailing edge	3	1%
Leading edge debonding	9	4%
Covered drain holes	6	3%

Typical defects due to aging and working hours

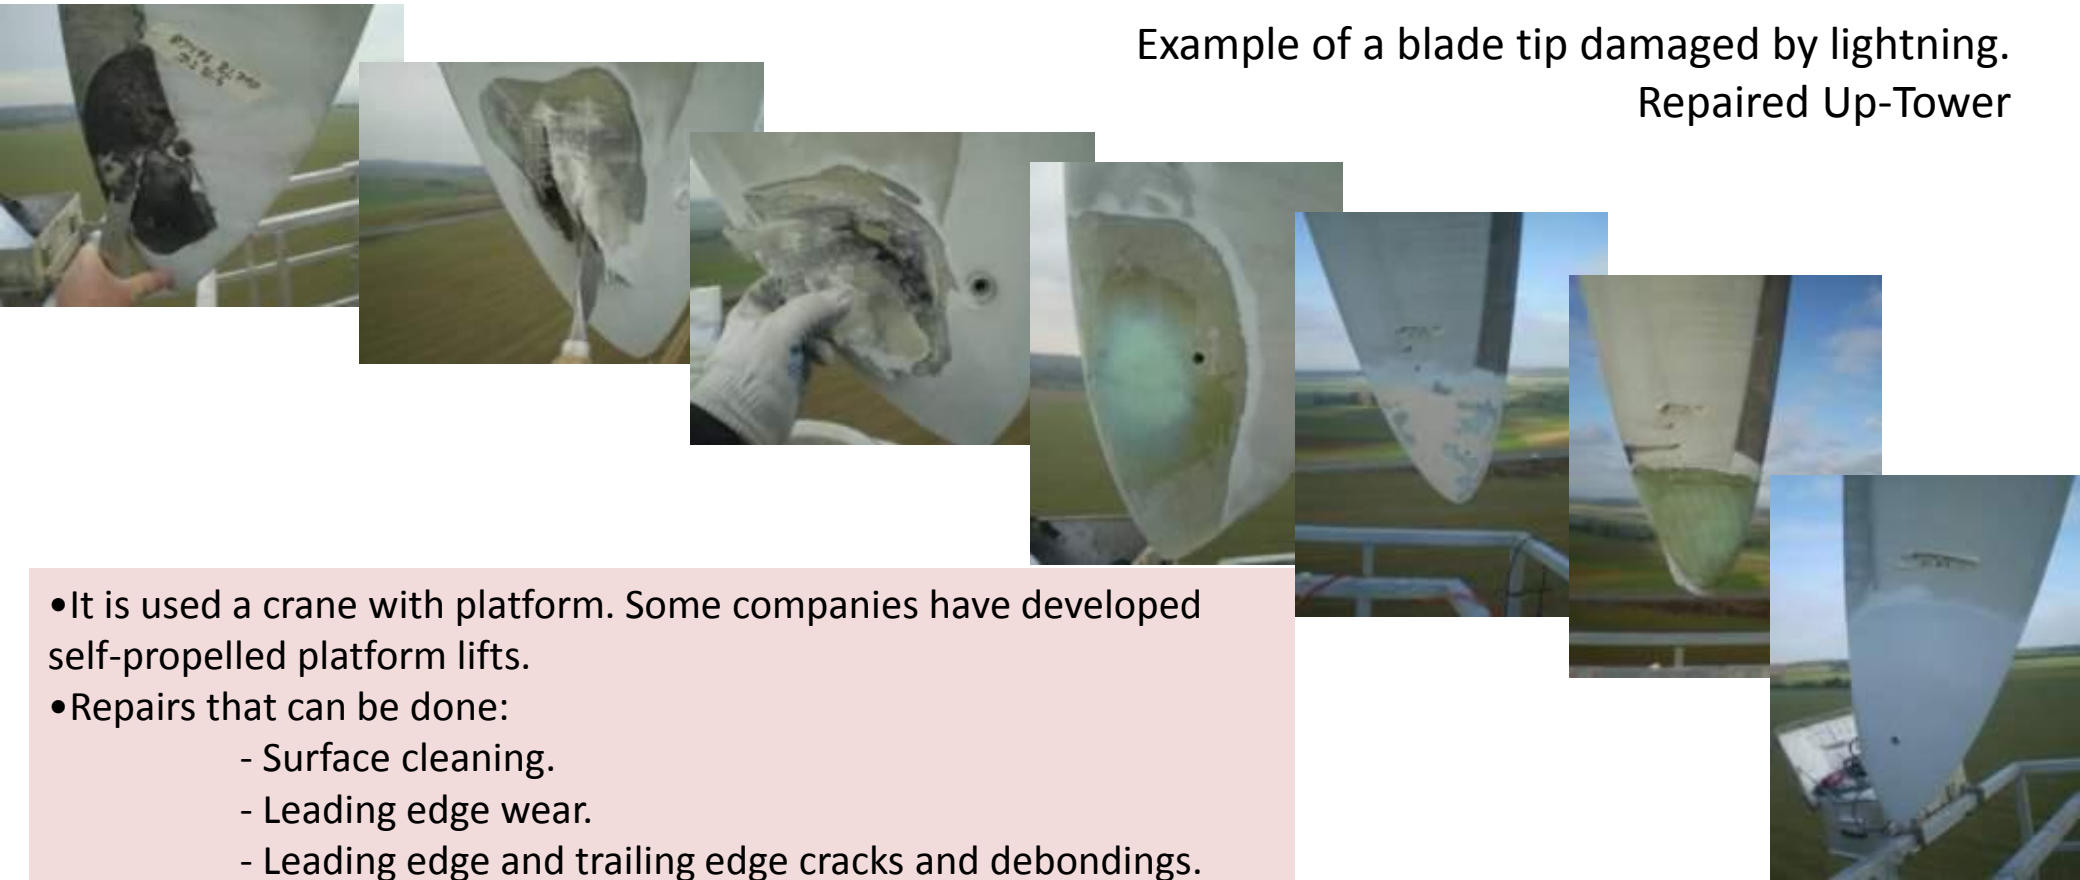
Example of a blade tip damaged by lightning.  
Repaired Up-Tower

- It is used a crane with platform. Some companies have developed self-propelled platform lifts.
- Repairs that can be done:
  - Surface cleaning.
  - Leading edge wear.
  - Leading edge and trailing edge cracks and debondings.
  - Detachments of the external coats.
  - In some cases: important structural root cracks.
- Repairs are done by the blade manufacturer (usually if blades are under warranty) or by a ISP.

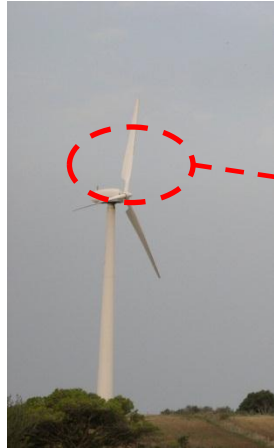
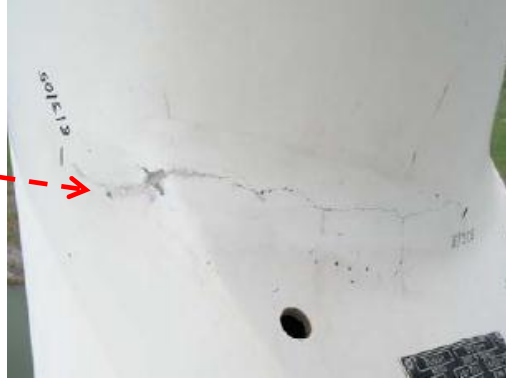
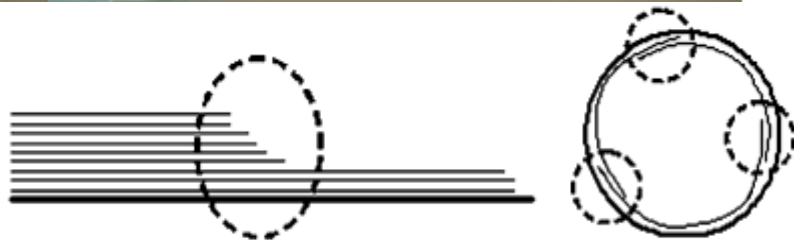
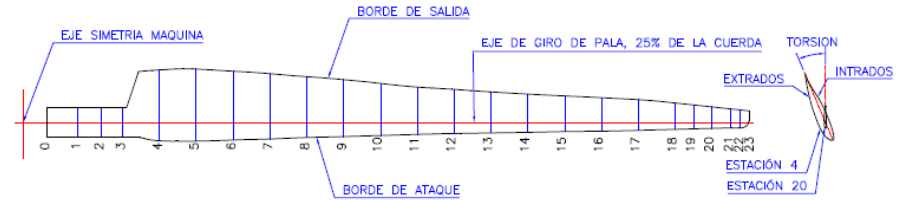
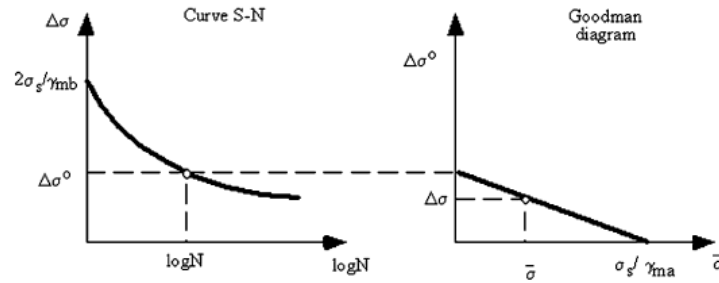
# Design Failure – Root cracks

$$D = 6.919 \times 10^{-3} \frac{N_{max}}{((\sigma_s / \bar{\sigma}) - 2.67)^9}$$

This stress is influenced by concentrated factor, which was higher due to manufacturer process

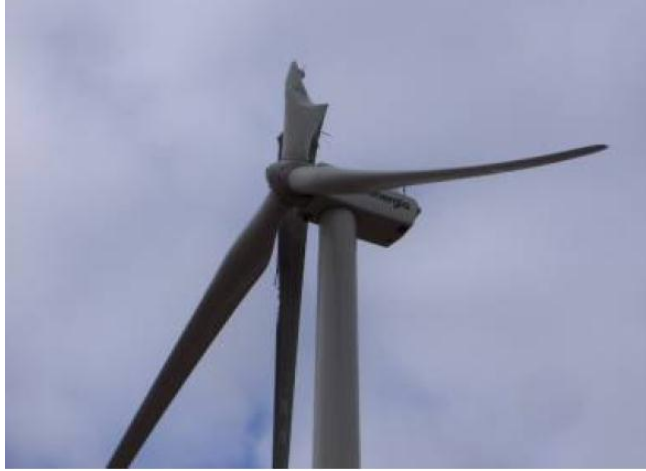
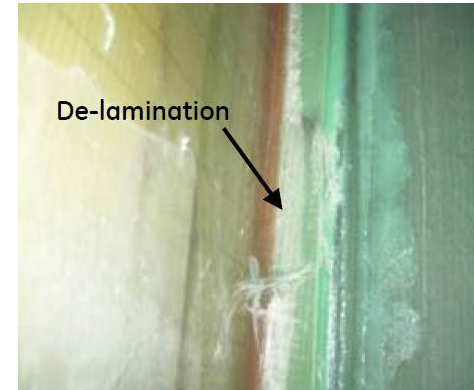
# Design Failure – Root cracks and web delamination

Bad blade design induced that 1 year after operation started some blades collapse.

All fleet was repaired, EDPR was close of WTG manufacturer to define the correct reparation.

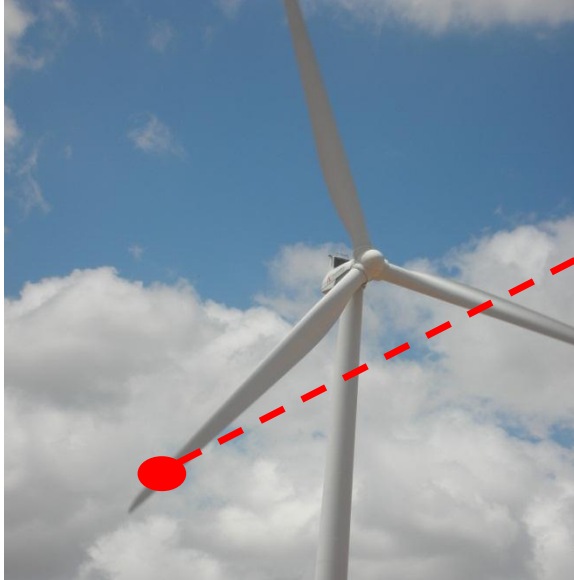
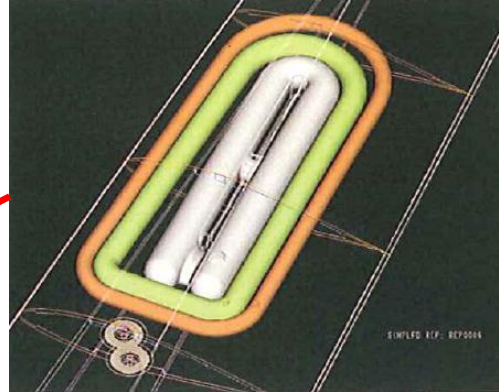
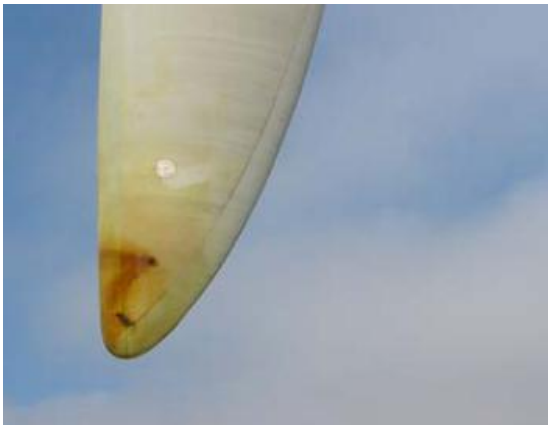
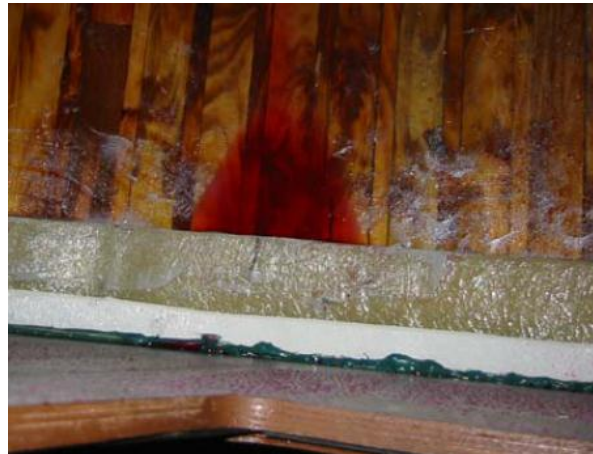
# Design Failure – Edgewise vibration (I)

Visual inspections and increase of shutdowns permit detect the problem.

Blades with dampers which permit damping the edgewise vibration.

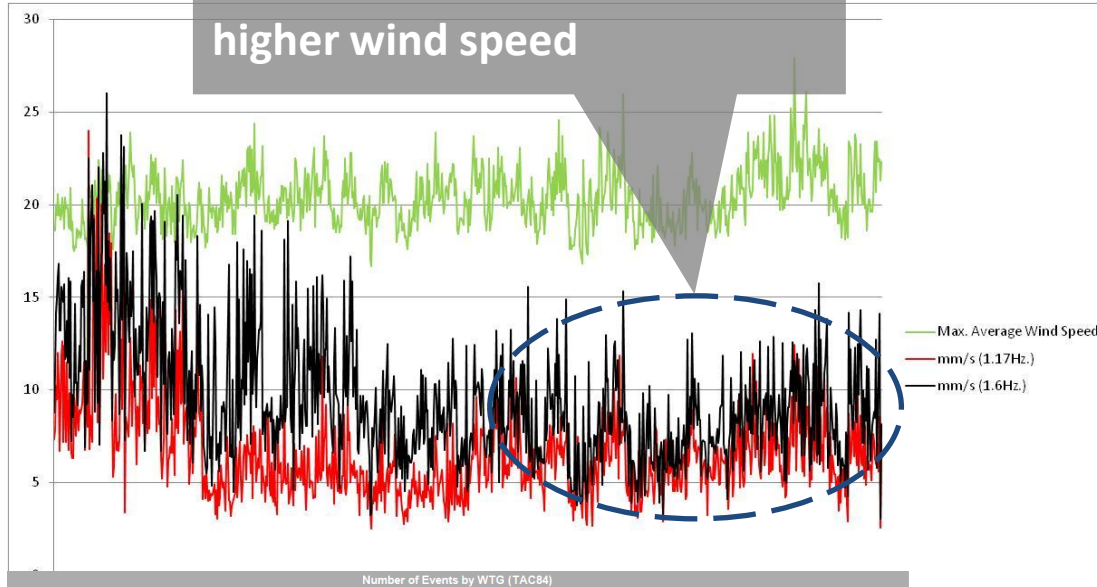
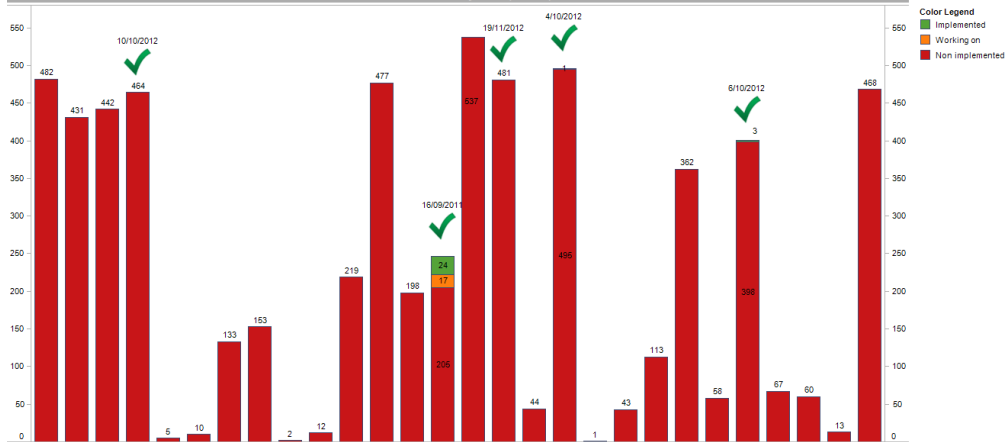
# Design Failure – Edgewise vibration (II)

Vibration levels are lower with higher wind speed

Level Vibration Decrement continue from dampers were repaired in the two alarm frequencies

- 1.17 Hz – 0.45 m/s<sup>2</sup> First Center Frequency
- 1.66 Hz – 0.45 m/s<sup>2</sup> Second Center Frequency

Retrofit applied has solved the losses due to WTGs shutdowns

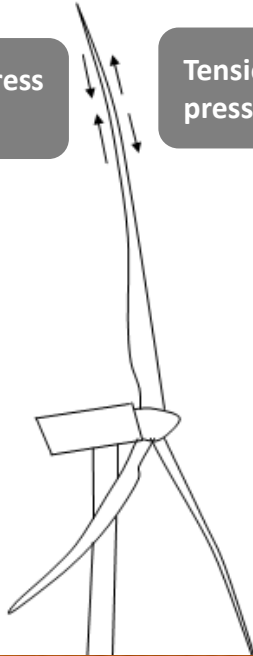
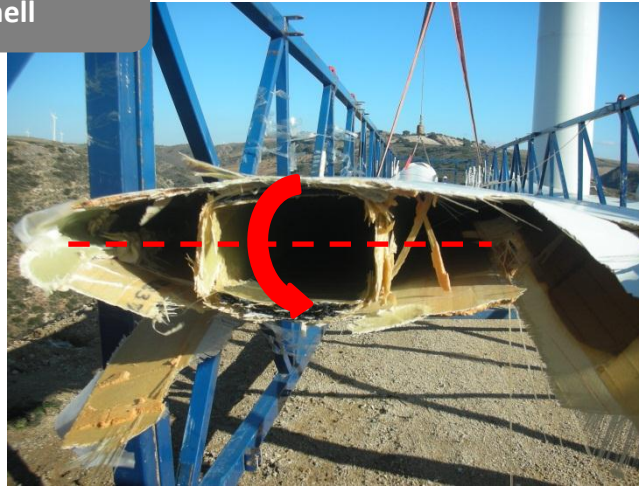
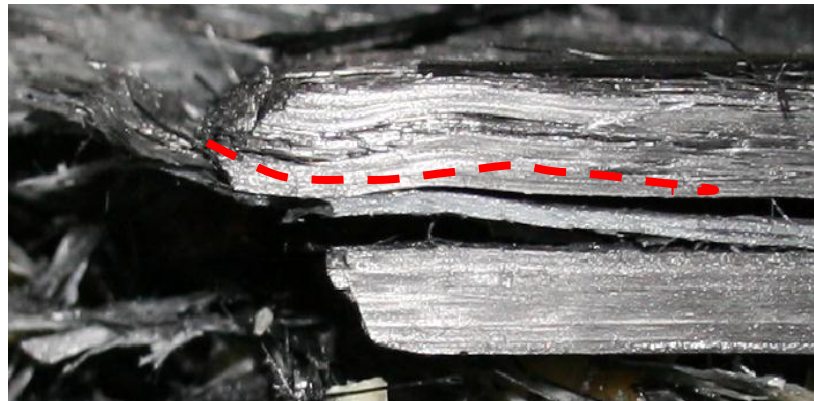
# Manufacturing process – Wrinkles

Compression stress in suction shell

Tension stress in the pressure shell

Wrinkles induced that in the compressed laminated appears micro-buckling which induced a crack that grow up in all thickness.

- Error during lay-up.
- Error during curing process.

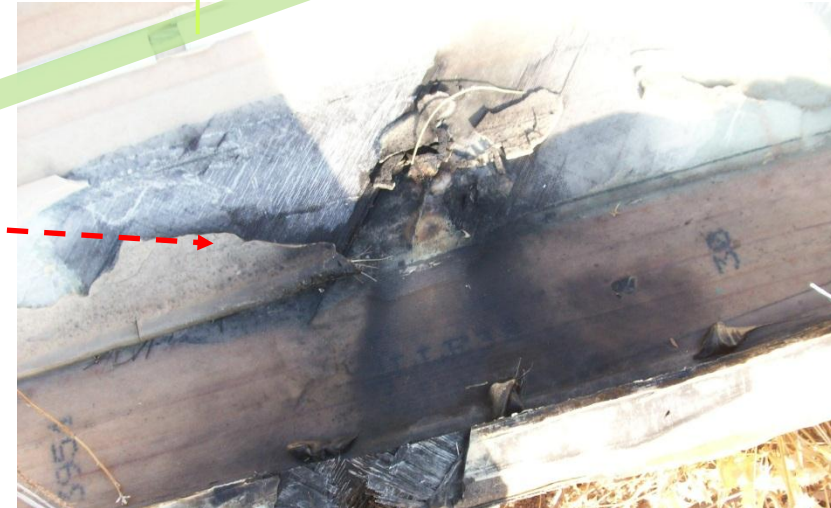
Lightning was not absorbed by tip receptor.

- Necessity to improved tip zone
- Introduce upgraded as Diverter Strips

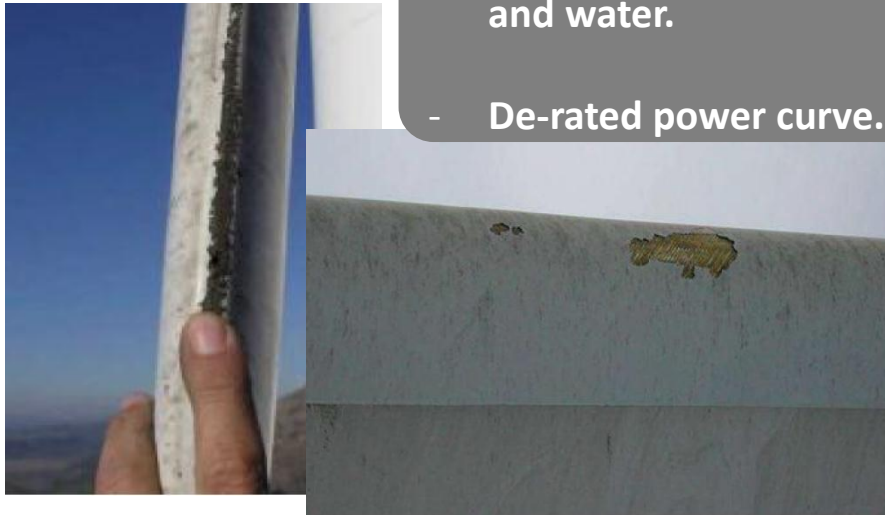
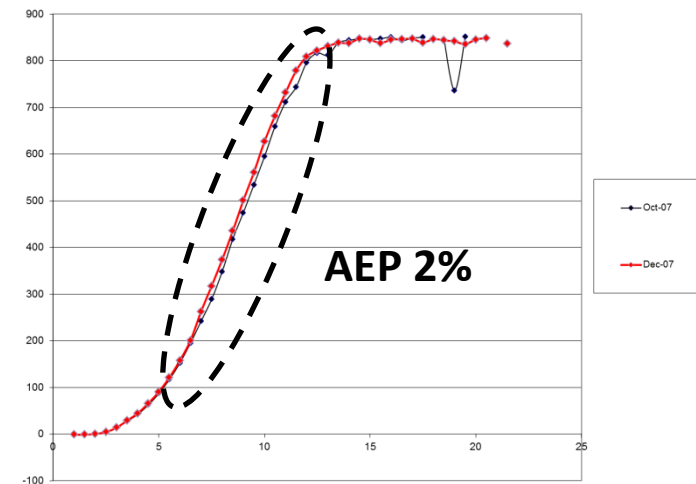
# Erosion

- Lack of protection against UV and water.
- De-rated power curve.
