Concrete problems today are multifactorial -

Root Causes – by Hamid Khan

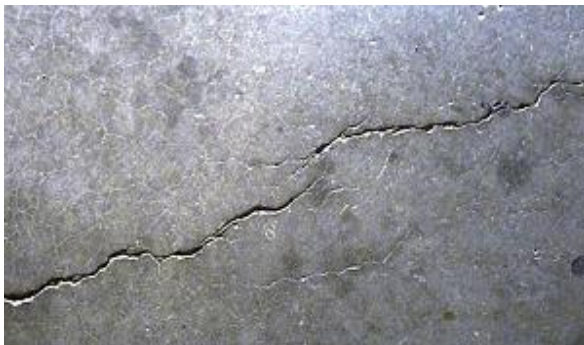
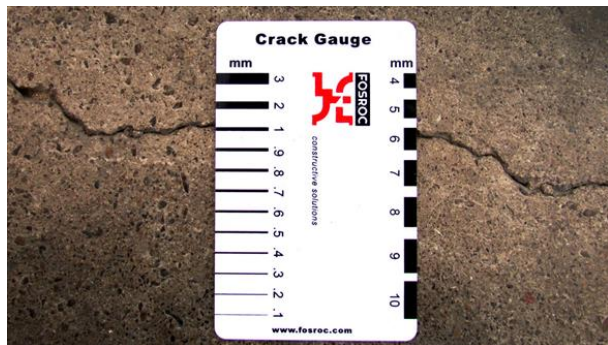
Concrete Cracks provide easy access to corrosive agents

Corrosion of the steel generates iron oxides and hydroxides, resulting in the increase of volume 5 to 10 times of its original size. This increase in volume causes expansive forces to accumulate within the concrete around reinforcement and results in concrete spalling. Cracks provide easy access to oxygen, moisture, chlorides and other corrosive agents - the conditions suitable for electrochemical corrosion process. Bridge girders often exhibit unexpected end cracking upon pre-stress release, a concern for bridge asset owners. These cracks propagate into the bottom flange of the girder where strands are located and can increase in width with increased traffic loads. Leakages from bridge expansion joint penetrating the bottom flange cracks could easily trigger severe corrosion currents. In this case expansion joints leakage must be arrested prior to the crack and concrete repair activity.

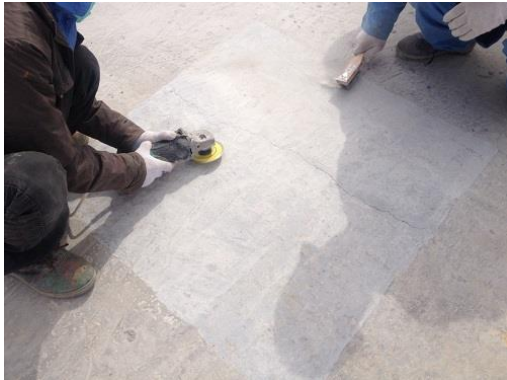
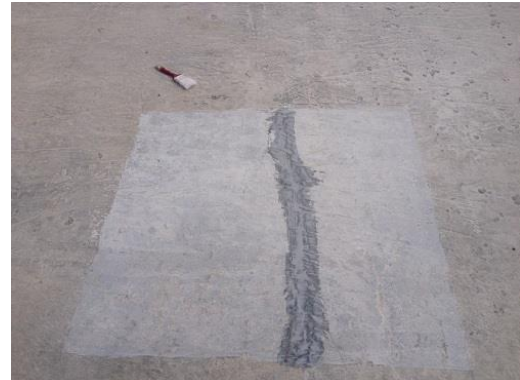
Linear Transverse cracks on new bridge deck due to plastic shrinkage- Surface grinding to open the face of the crack and sealing with epoxy resin

A common and predominant form of cracking at an early age on new concrete bridge decks is known as *transverse cracking* which appear along the length of span over transverse reinforcement. These cracks accelerate corrosion rates, reduce the service life of the asset and increase maintenance costs. Multiple factors such as materials and concrete mix design, ambient temperature changes, humidity, bridge design characteristics and construction practices that contribute to volume change and/or to degree of restraint of concrete mass result in cracking. Transverse cracking cannot be attributed to all the above factors. It is important to identify the major contributing factor(s) to address the root cause of cracking.

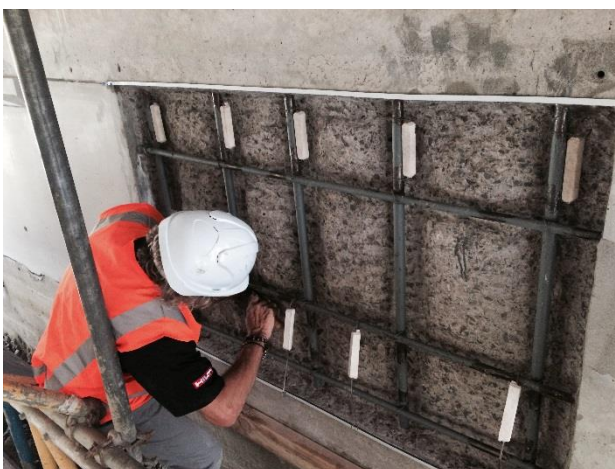
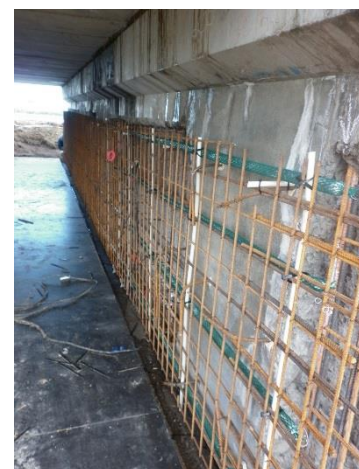
Cathodic protection to bridge piers affected by cracks, corrosion and spalled concrete, using embedded galvanic anode units 'Galvashield XPT' (left) and distributed galvanic anode system 'Galvanode DAS' (right)

A crude approach while examining the corrosion induced damage in bridge structures, particularly in the marine environment, is to assume the presence of chlorides as the main cause of failure. Chlorides might be the reason of corrosion but not the actual cause of the bridge defect. The root cause of failure of the bridge structure cannot be attributed to corrosion. There are many factors involved that could lead to corrosion and ultimately lead to failure of the bridge, such as, cracks in bridge girder web and flange, poor bridge drainage system, failed bridge deck waterproofing membrane, inappropriate bridge joints, void in the prestressed or post tensioned cable ducts due to excessive grout bleed. Other factors at macro level are related to design, material, environment and construction practices. It is important to address the main contributing factor(s) of the defects in bridge structures affected by corrosion.

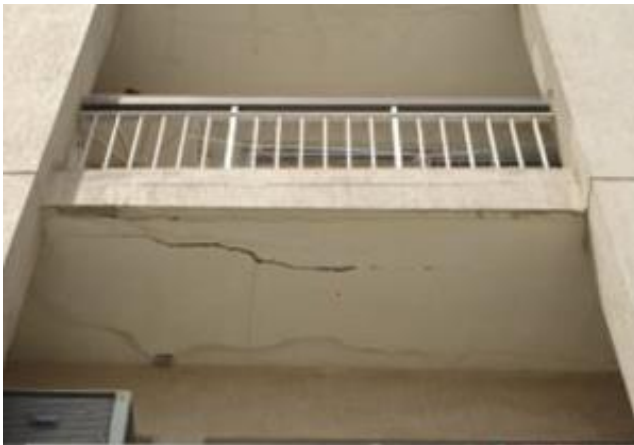
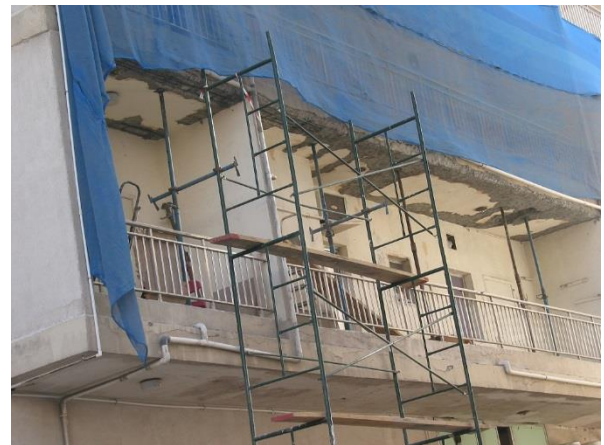
Balconies concrete corrosion and spalling due to multiple factors

Concrete repairs conducted without considering the actual source are ‘cosmetic repairs’ and last only for few months. For instance, repairing the spalled concrete of a balcony with quick-fix patch method, even applying the best quality repair mortar, would not solve the problem unless the root cause has been identified and addressed. It could be attributed to more than one cause such as leakage due to failure of waterproofing membrane, an AC drain pipe leak, faulty concealed pipe joints or the combination of these factors. Corrosion of reinforcement that has caused spalling of balcony is not the root cause here.

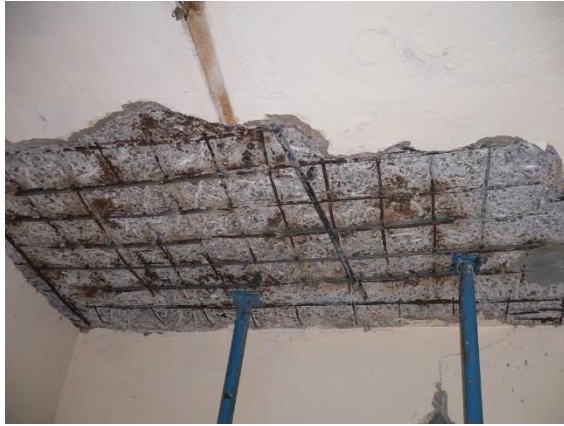
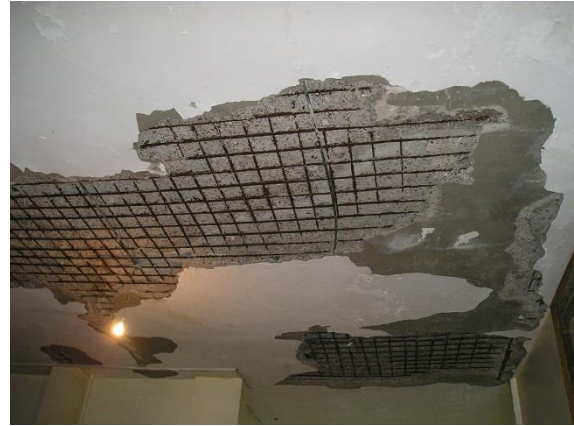
Soffits severely corroded due to roof leakages of a residential building

Roof leakages in the buildings result in seepage to the flats below. This causes discomfort to the occupants and frequent disputes between the landlord and the tenant in regard to the liability to repair. The failure of roof waterproofing is often attributed to the poor workmanship. Based on this notion, the roof refurbishments are carried out but the leakages appear again after some period of time. A research conducted by Leung and Cui (2005), on roof construction defects have highlighted that the root cause of failure of the roof waterproofing membrane stems from the roof parapet wall cracks. It further concluded that the design and choice of material for roof parapet wall is critical to avoid the waterproofing membrane failures on the roof slab. Other reasons of roof leakages could be wrong termination details of the waterproofing membrane at up-stands and drains, improper selection of the waterproofing system and poor roof joint detailing.
