# **Wind farm owner's view on rotor blades – from O&M to design requirements**

**BREMEN 25-27, February 2013**

**Antonio Herrera Sierra  
Eduardo García Pérez**

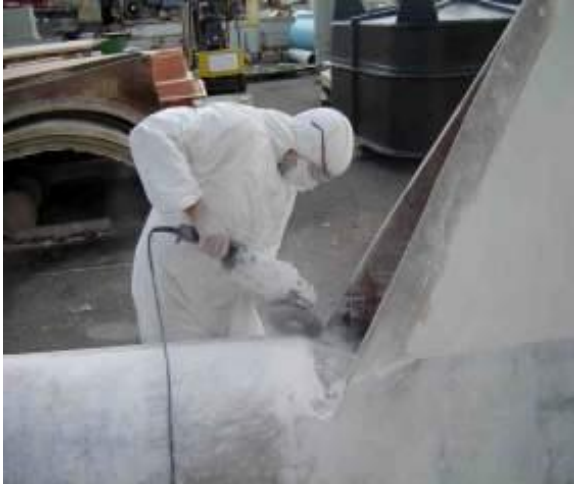
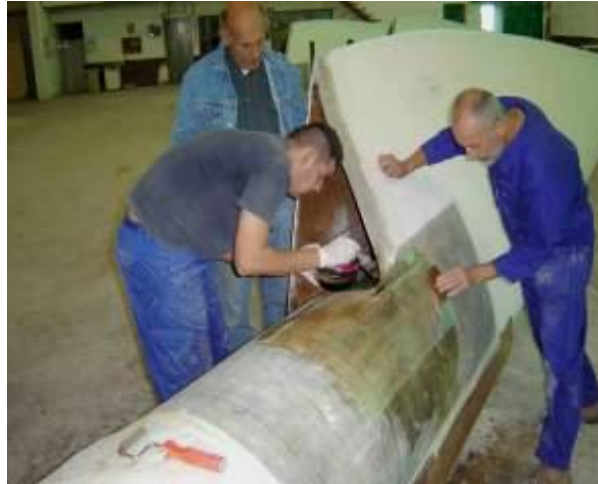
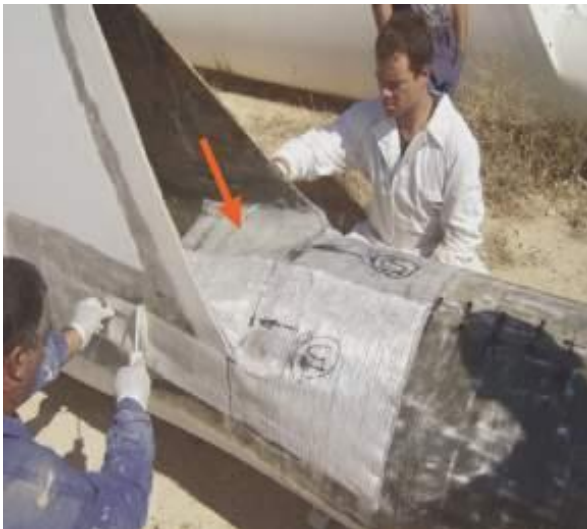
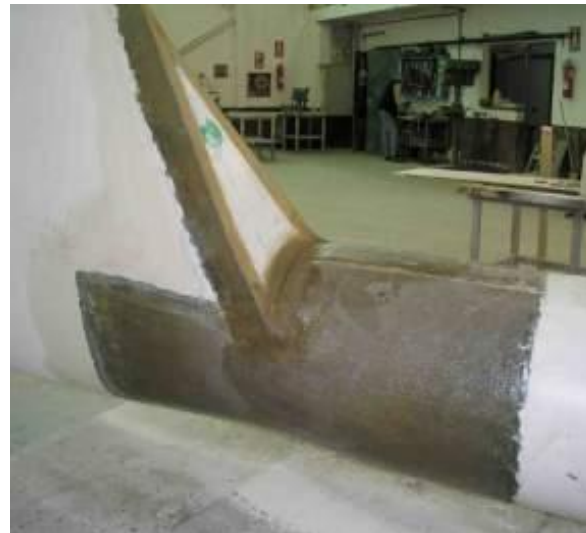
Some damages on blades require disassembly the blade to repair on the ground, or in a workshop or even require to replace the blade by another one

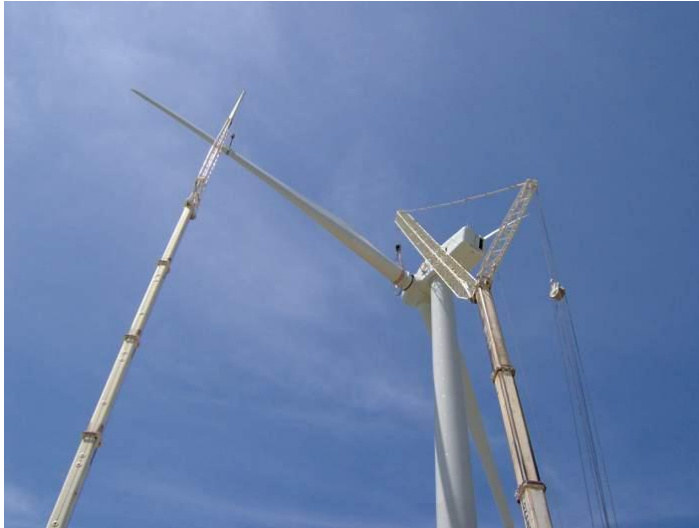
Average Annual Failure Rate below 1% (0.5 – 0.75%)  
Some years there is a peak because of a massive blade failure (design or manufacturing error) or a particularly aggressive lightning storm season

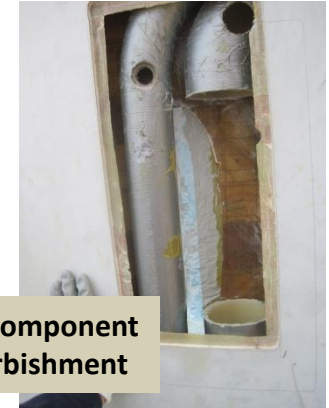
**Wrong geometry**

**Wrong subcomponent fatigue life**

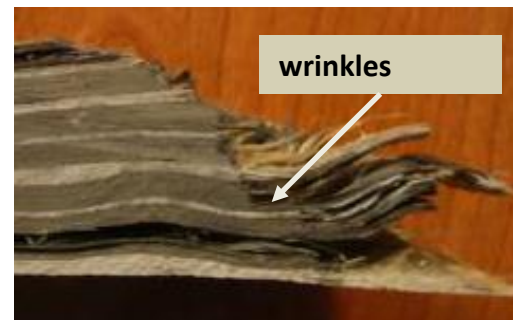
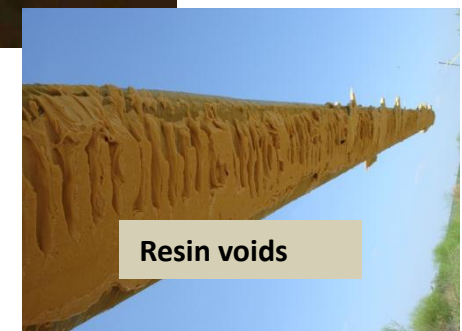
**Resin Voids**

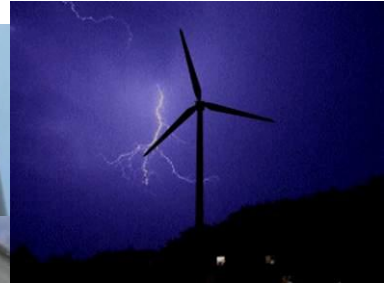
**Lightning**

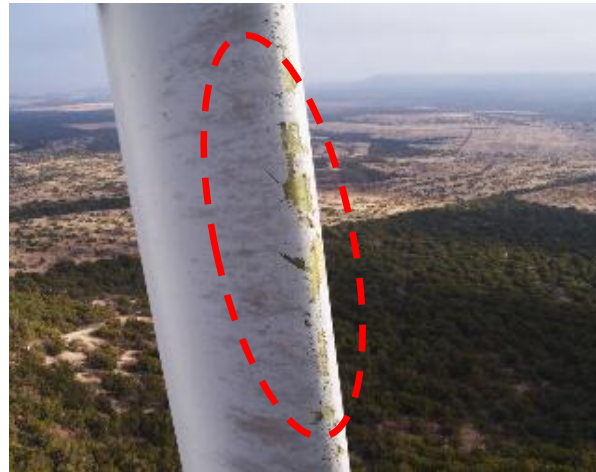
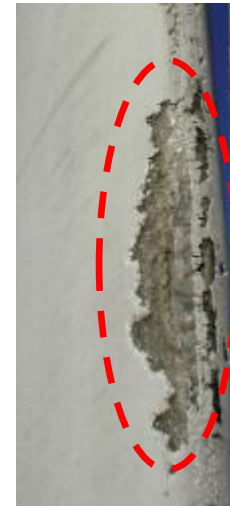
**Erosion**

**Leading edge**

**Gel Coat**

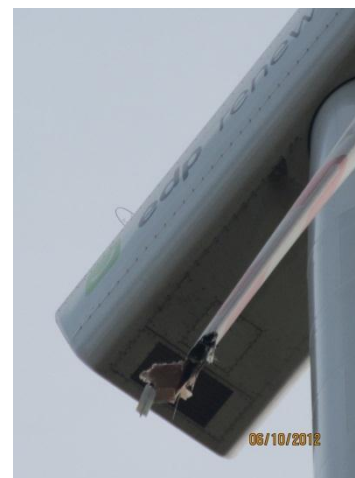
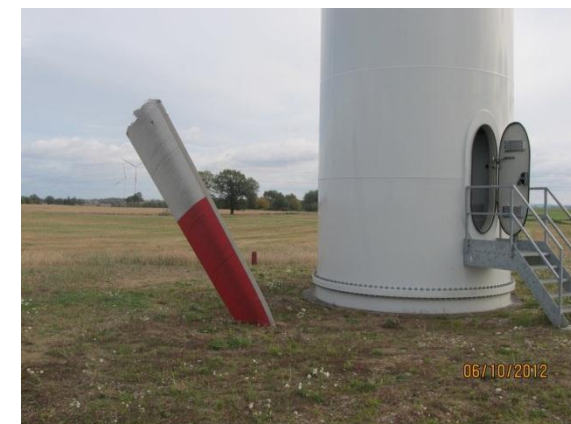
\* Título: Failure on blade beam

\* Descripción: Failure has been produced in one blade of AG-3 in Korszse. This failure has occurred in other EDRP wind farms

**Alcance de la Incidencia:**  
This failure is a fabrication problem which can affect to the rest of the wind farm.

GSX blades have developed different failures topology (broken beam, mid radius cracks, peel-off shells and lightning). The scope is analyzed the failure produced and ask technical information Gamesa in order to detect what's root cause analysis. This incidence can relate to Guadataba incidences due to is the EDRP-EU wind farm where major blades failures have been developed.

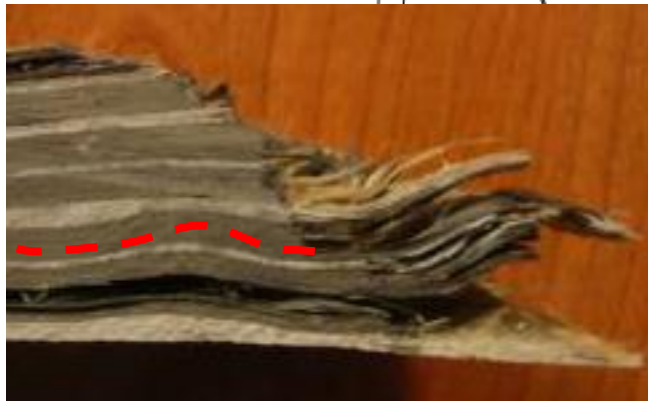
Wrinkles induced that in the compressed laminated appears micro-buckling which induced a crack that grow up in all thickness.

- Error during lay-up.
- Error during curing process.

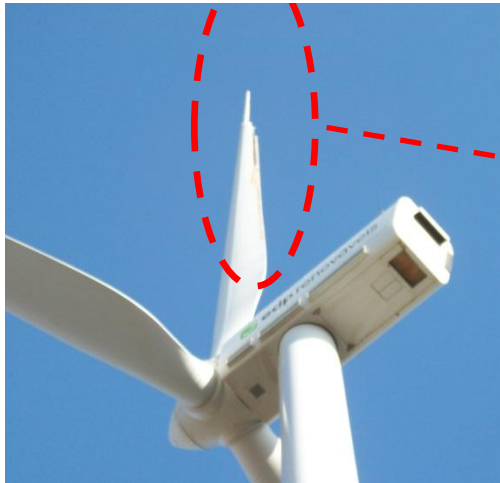
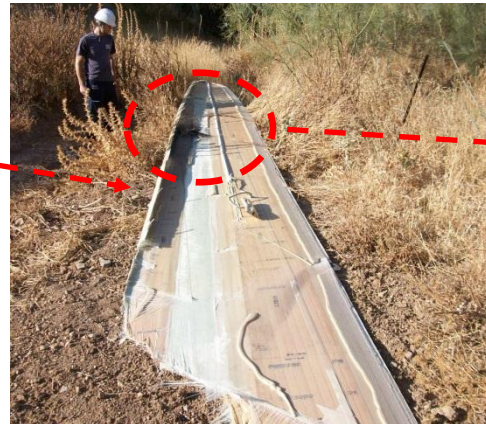
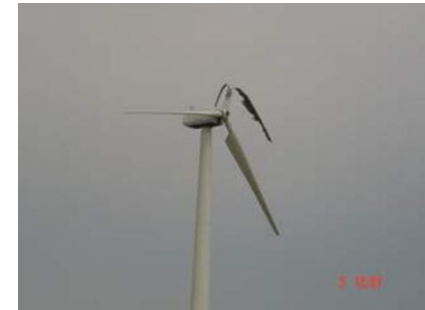
Cable receptor

Lightning was not absorbed by tip receptor.

- Necessity to improved tip zone
- Introduce upgraded as Diverter Strips

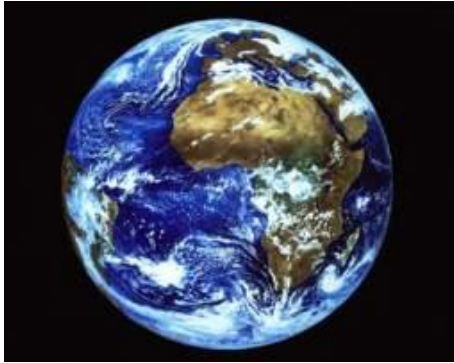
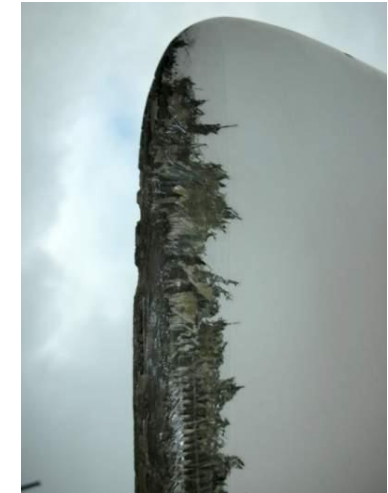
The tip of a blade travels in 1 week a distance equivalent to a round to the world.

- Lack of protection against UV and water.
- De-rated power curve.
